29th Floor

REVISIONS		BY
PROJECT: DIPLOMAT OCEANFRONT RESIDENCES CONDOMINIUM ASSOCIATION, INC. 3535 S. OCEAN DRIVE HOLLYWOOD, FL 33019		
PROJECT NO: 1918 SOUTH BULEVARD, SUITE 200 HOLLYWOOD, FL 33020 CERTIFICATE OF AUTHORIZATION NO. 33000		
BID SET		
PROJECT: BALCONY & STUCCO REPAIRS DIPLOMAT RESIDENCES (DATE: 1/28/2022)		
MVA PROJECT NO: 248001		DATE: 1/28/2022
SCALE: AS SHOWN		DESIGNED BY: LAH
DRAWN BY: JHM	CHECKED BY: LAH	
A3		
SHEET		OF 16

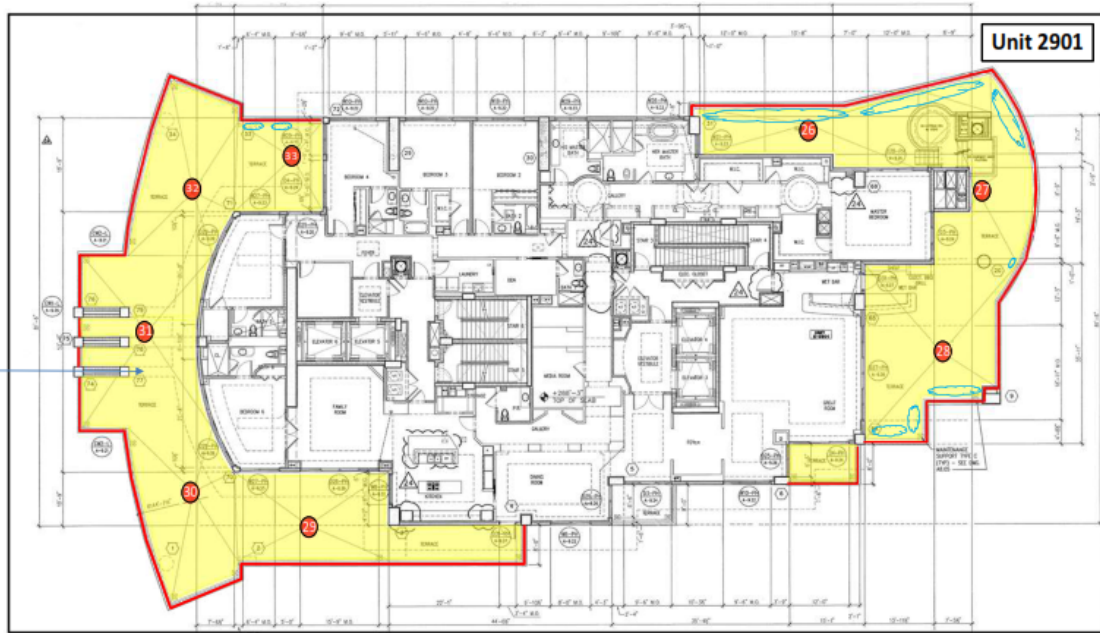
Unit 2901

Loose metal coping above flat arch.

Per the Association’s Engineering Consulting report, this unit will require drainage system repairs on the balconies. The buyer will be responsible for replacing the balcony flooring at their own expense.
